General Warranty and Roof Claim Procedure

ArcelorMittal

Chromadek® for Exterior Applications
Pre-painted hot-dip galvanised steel sheet

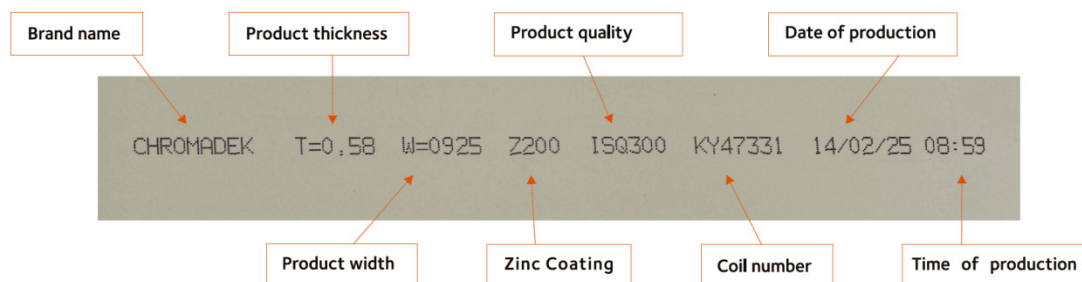
ArcelorMittal South Africa's Chromadek® is branded on the underside, along the length of the sheet, approximately 5cm from the edge (pre 2009) and 140mm from the edge (post January 2009), with a dot-matrix printer. Inspection of the roofing sheets should be conducted under the eaves or on the inside of the ceiling in order to identify the coil number because sometimes the branding is covered by the overlap. The ArcelorMittal South Africa production number starts with the letters KQ or KP and is then followed by a 5-digit code. This number enables ArcelorMittal South Africa to retrace the coil through the manufacturing processes.

Example of Chromadek® branding below:
